LIA - BUILDING PUNCH - SCOPE OF WORK

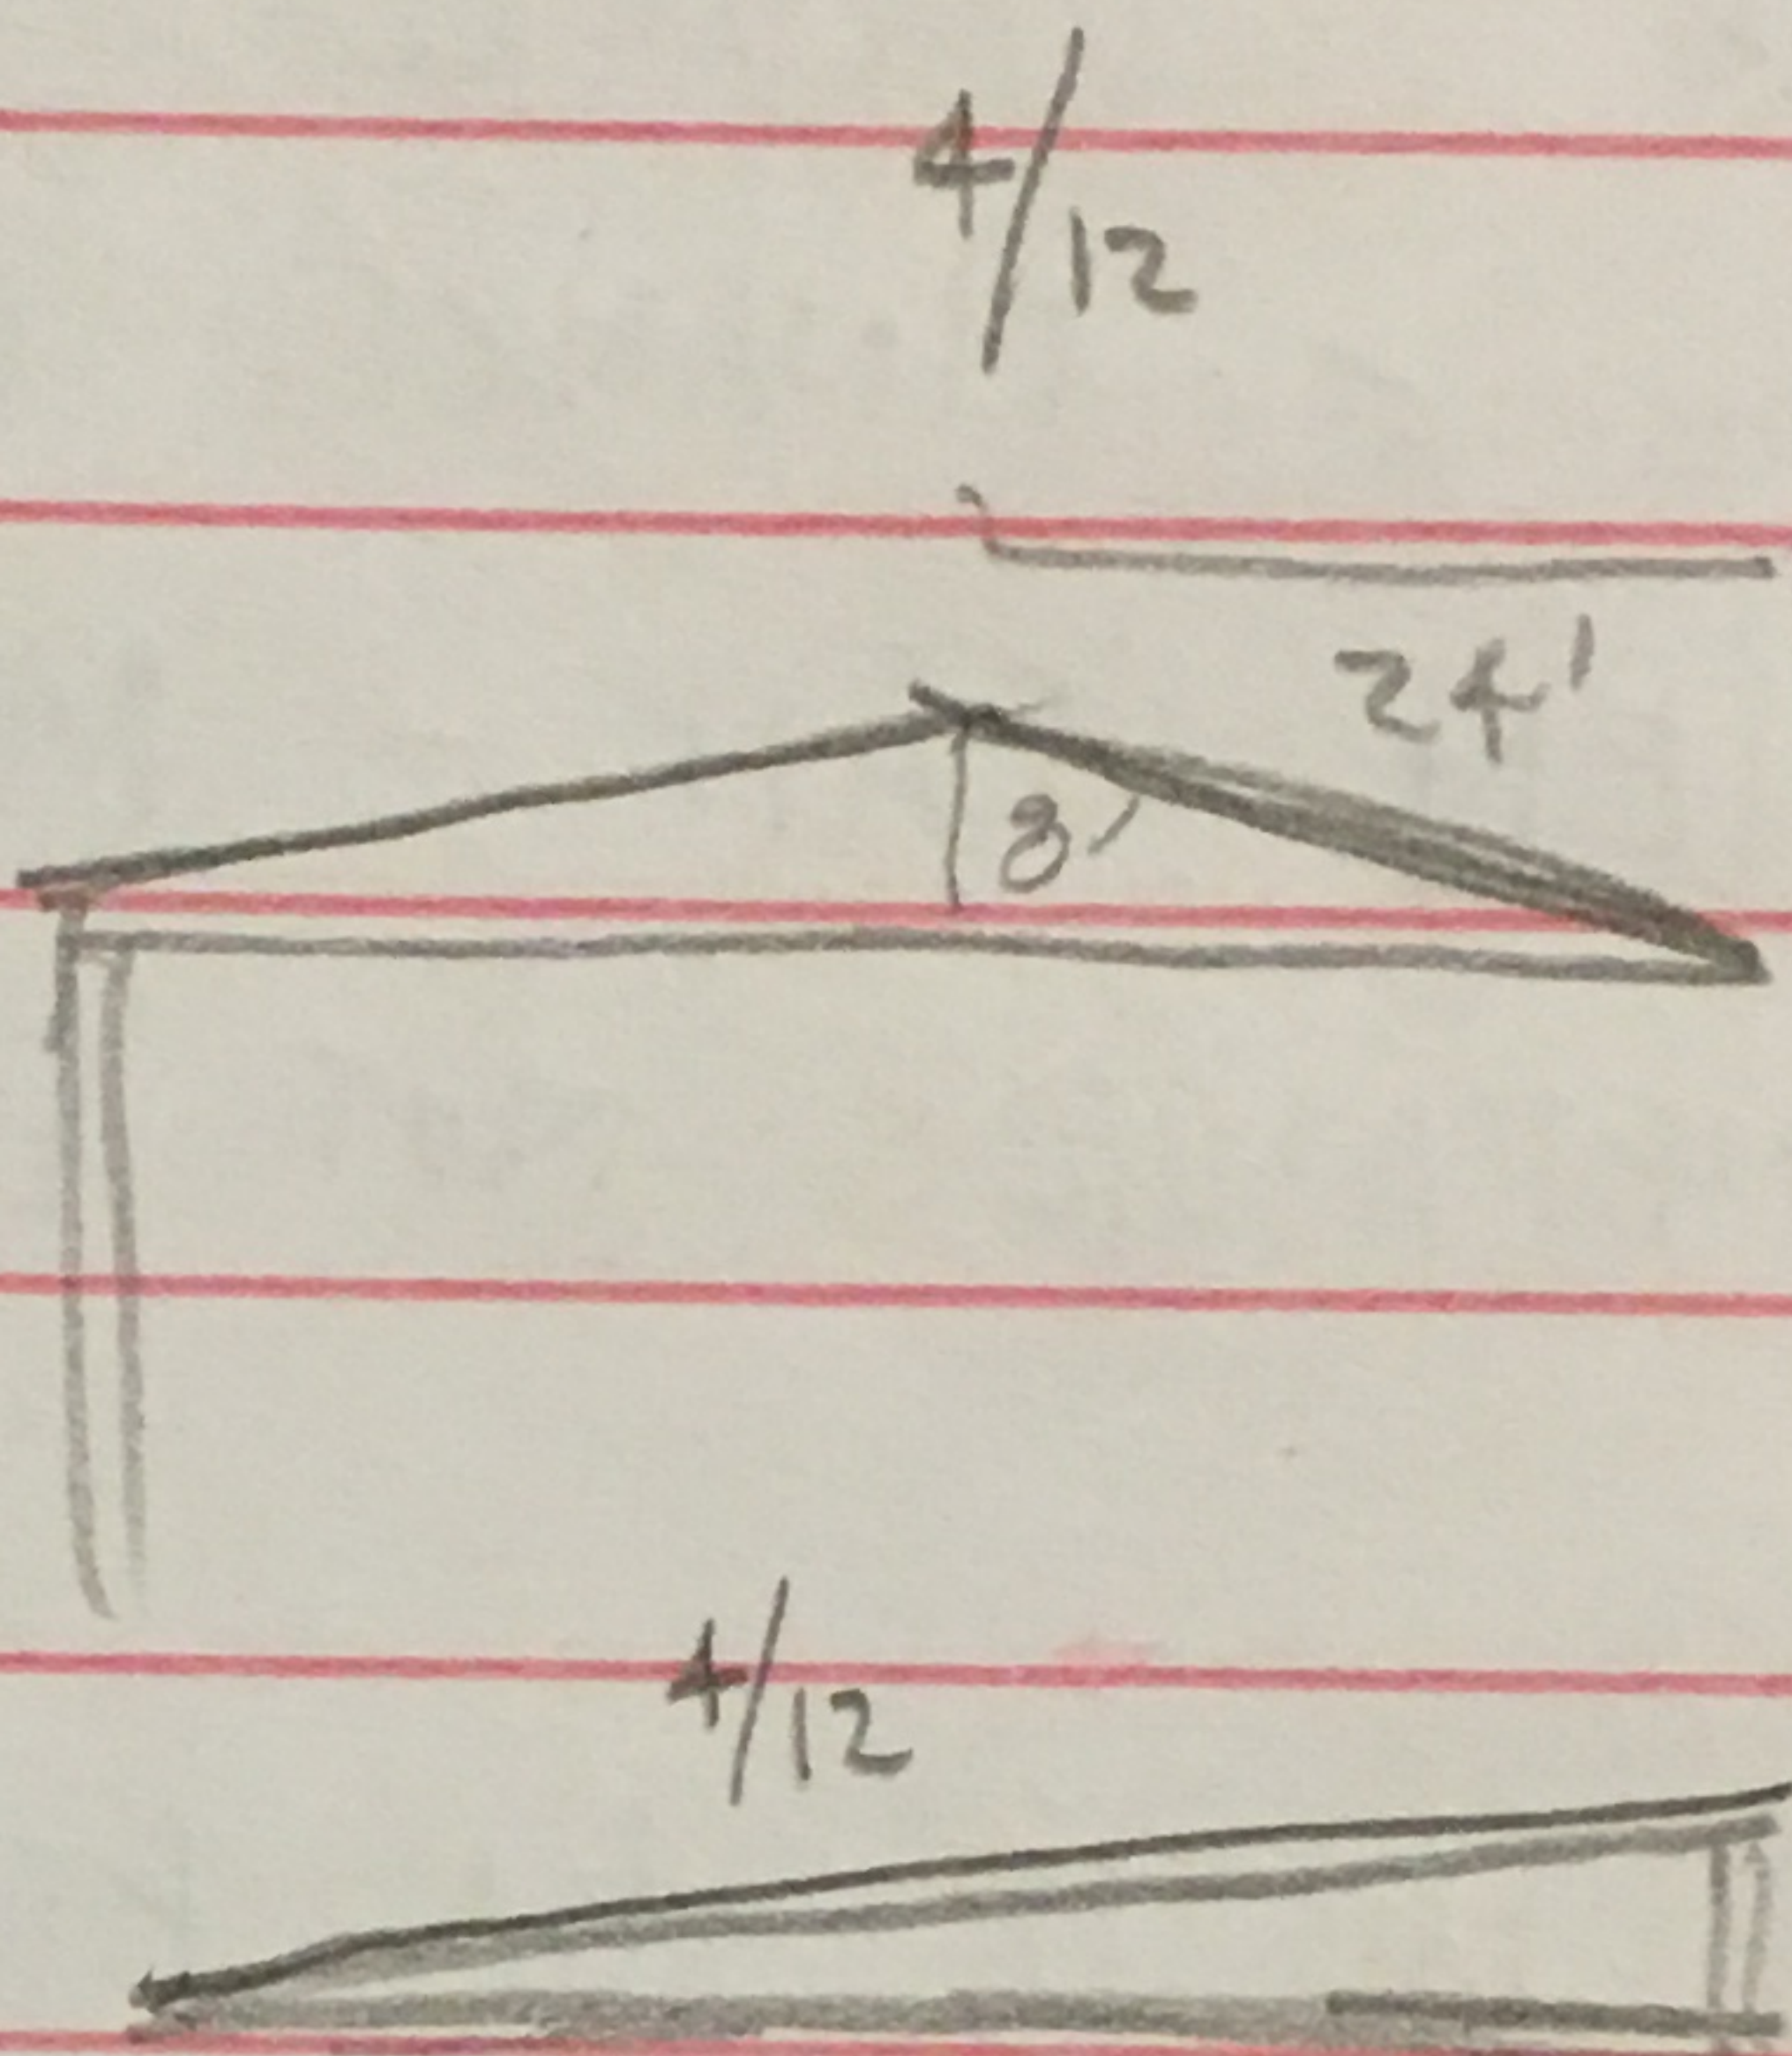
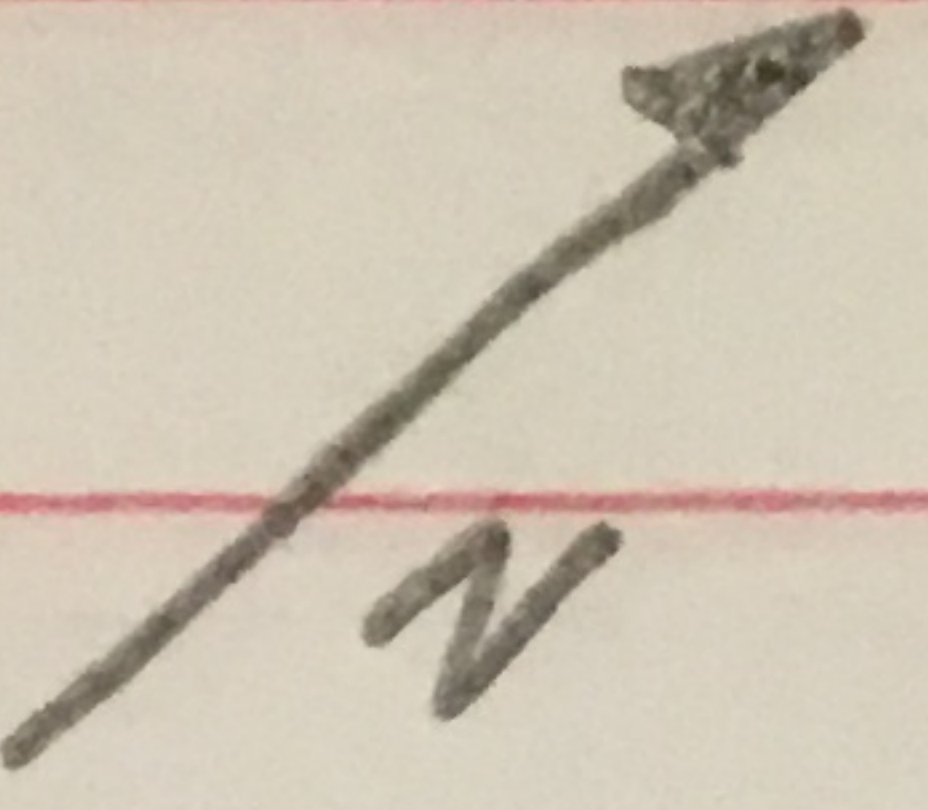
BUILDING 2

- ELECTRICAL - 220 ~~V~~ 116 CONVERSION STRIPS
- FIX ROOF
- FIX FOOTINGS
- SUBFLOOR
